March, 2015

# Case Study - SPX maintenance expertise quickly restores a flooding separator to correct operation

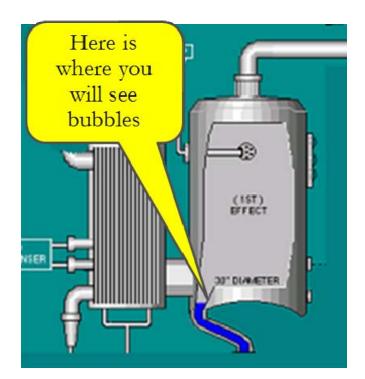
As a further check the water was kept circulating so there was water in the separators without vacuum and shut down everything else. The feed flow control valve was then manually closed to isolate the system on the feed side to prevent water from the balance tank being sucked in when vacuum was applied. Next, the vacuum was started to look for bubbles in the discharge area of the separator vessel caused by air being sucked in through the leak. A trail of small bubbles indicated a small leak, a larger leak may result in violent eruptions. Note that it is important that the vessel and the water are cold, otherwise the water may boil under vacuum giving a false result. This usually shows up as bubbles on the entire surface of the water.

To localize the leak, all of the clamp fittings were tightened to see if the bubbles subsided – success! If the leak had been from the pump's inner mechanical seal it would be sucking air in from the service water discharge tubing along with the service water that should be going on the floor. The service water line is the ¼" poly-flow tubing coming out from between the pump head and the motor. The test is to turn off the seal water to the pump and pick up the discharge tube to feel if air is being drawn into it which would indicate a front seal leak. The seal should then be replaced.

As a final step, the process should always be repeated to verify that all leaks have been corrected. There may, of course, be more than one. This can involve breaking down all the product lines below that vessel's water line, replacing gaskets, and maybe even replacing clamps with good quality SPX brand clamps. A final word of advice: It is vitally important that the lines and gaskets align without stress. Cut and weld new lines if needed. If the lines have to be pulled into position there will be problems in the future. For more information, please contact....
