Polyisoprene Lining for Vacuum Pump Reconditioning

A reliable and cost effective solution for pumps used in corrosive and erosive processes.

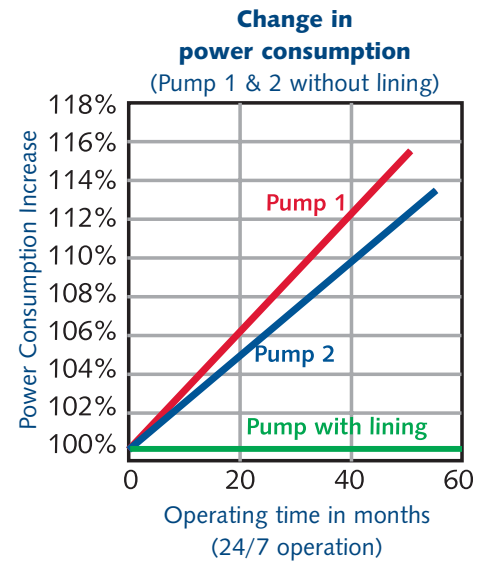
The graph at right is based on actual field measurements. It illustrates the power consumption increase of two vacuum pumps with standard unlined casings, over a period of about 50 months, in a paper mill with a closed water system. Absorbed power was in the range of 114 to 116 percent and still rising.

The casing of a liquid ring vacuum pump is especially prone to this type of wear, because it is in contact with the liquid seal. Typically, after prolonged exposure to these corrosive and erosive elements, the surface of the casing becomes rough, which increases the friction factor. This results in an increase in the amount of energy required to rotate the liquid ring. Nash has measured power consumption increases of up to 20 percent under these circumstances.

Test pumps were disassembled, lined with polyisoprene and then returned to their original service, with the following results:

- power consumption was reduced to the same level as when the pumps were new
- no future power increase over time, even though the water conditions remained unchanged
- periodic internal inspections over time showed no signs of casing wear
